Manhole Inspection Summary

Manhole # S65M__003MH

Location Address: **5801 O'Donnell St.**

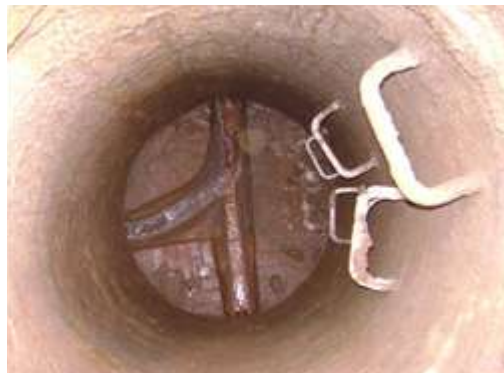
Top View

Condition: ☐ Sound ☐ Cracked ☐ Root Intrusion ☒ **Loose Brick** ☒ **Deteriorated**

Infiltration: ☐ None ☒ **Joint** ☐ Cracks ☒ **Mortar** ☐ Roots ☐ Wall

infiltration evidence in barrel

loose bricks at frame adjustment

infiltration at frame
